Performance of concrete in real fires

Over the past two years there have been two very extensive fires in concrete buildings in the UK. Overall, these concrete structures maintained their stability during the fires, although it is likely both buildings will be demolished. **Tony Jones** of **MPA–The Concrete Centre** looks in further detail at the fires and discusses the performance of the structures. These fires show that concrete's inherent fire performance often exceeds the minimum required by regulation and this is an important factor for the safety of those around buildings that are on fire. But are these regulations adequate?

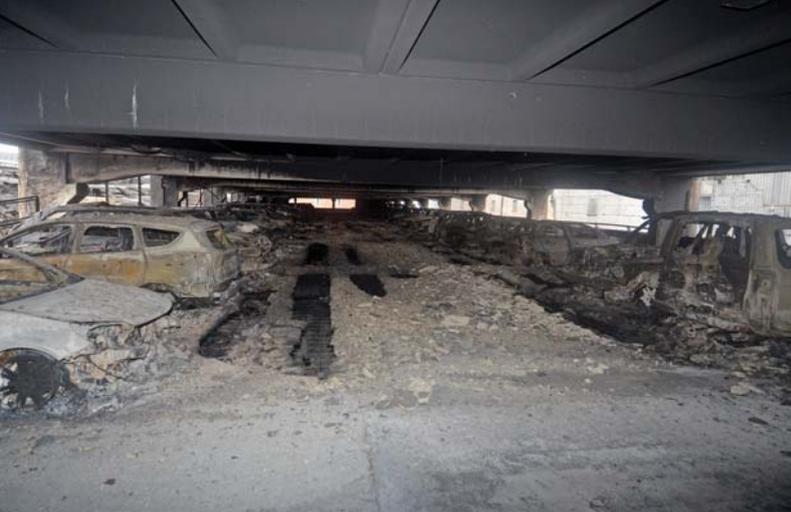
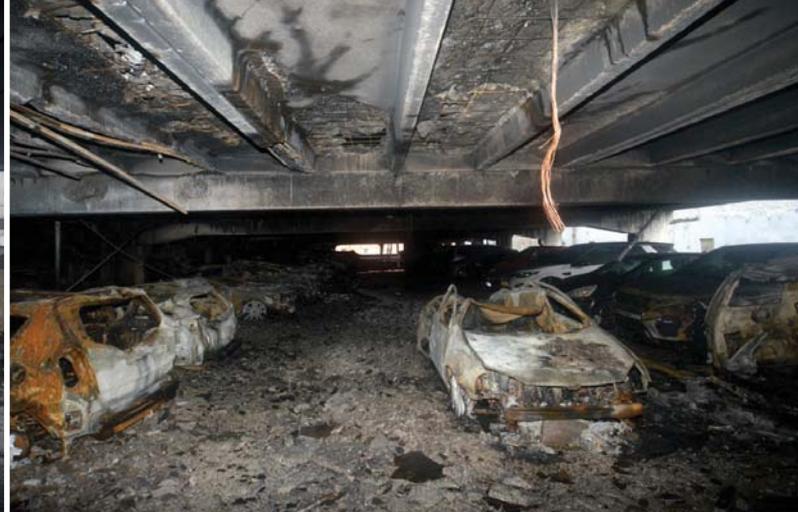
Above and below: From a structural stability point of view the Liverpool Echo Arena car park appears to have performed better than expected.

The rib slab of the car park was approximately 80mm thick, giving the required 60 minutes fire resistance. There were reports of burning puddles of fuel on the slab and it is perhaps not surprising that this slab failed between ribs in a number of places. However, in general, the ribs – which would also have had only a 60-minute fire rating – performed relatively well, with only one area of local failure reported. The stair core walls were 170mm thick (giving two hours fire performance) and along with their fire doors performed so well that the inside of the stair cores was undamaged.

Not only was the car park designed for a more severe fire than that required by Approved Document B but also from a structural stability point of view it appears to have performed better than expected by current design Codes. There were adjacent residential buildings within 6m of the car park and the consequences of a collapse would have been significant.
