Performance of concrete in real fires

Over the past two years there have been two very extensive fires in concrete buildings in the UK. Overall, these concrete structures maintained their stability during the fires, although it is likely both buildings will be demolished. **Tony Jones** of **MPA–The Concrete Centre** looks in further detail at the fires and discusses the performance of the structures. These fires show that concrete's inherent fire performance often exceeds the minimum required by regulation and this is an important factor for the safety of those around buildings that are on fire. But are these regulations adequate?

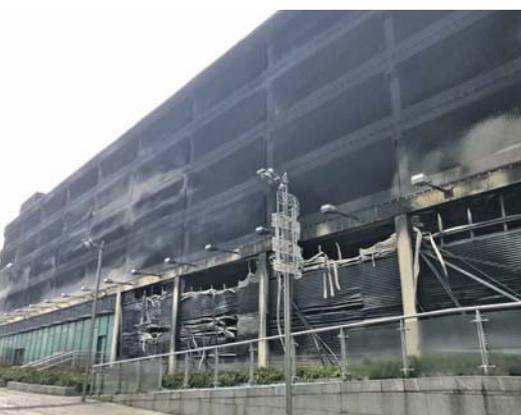
Liverpool Echo Arena car park fire.
(Photos: Merseyside Fire & Rescue Service.)

The rib slab of the car park was approximately 80mm thick, giving the required 60 minutes fire resistance. There were reports of burning puddles of fuel on the slab and it is perhaps not surprising that this slab failed between ribs in a number of places. However, in general, the ribs – which would also have had only a 60-minute fire rating – performed relatively well, with only one area of local failure reported. The stair core walls were 170mm thick (giving two hours fire performance) and along with their fire doors performed so well that the inside of the stair cores was undamaged.
